Vector PC Wing

Firmware Update Version 0.35, 0.57
Release Notes & Installation Guide

Release Date: 4/5/2016

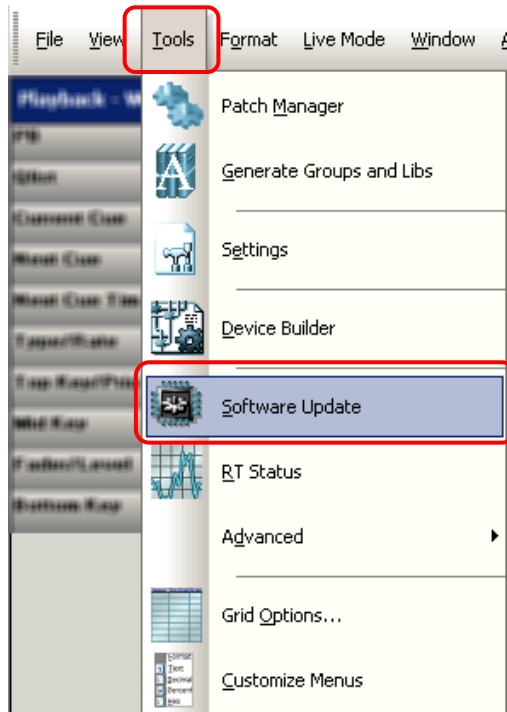
4. Copy the Firmware file from the USB or portable device to the Vector Updates folder:
 - For Vector console: *D:\Program Files\Compulite Vector\Config\Updates*
 - For Vector PC: *C:\Program Files\Compulite\ Vector Pc\Config\Updates*
5. Make sure the Vector console or Vector PC is ON.
6. From Vectors menu bar click on Tools ► Software Update.

The Update dialog window opens.

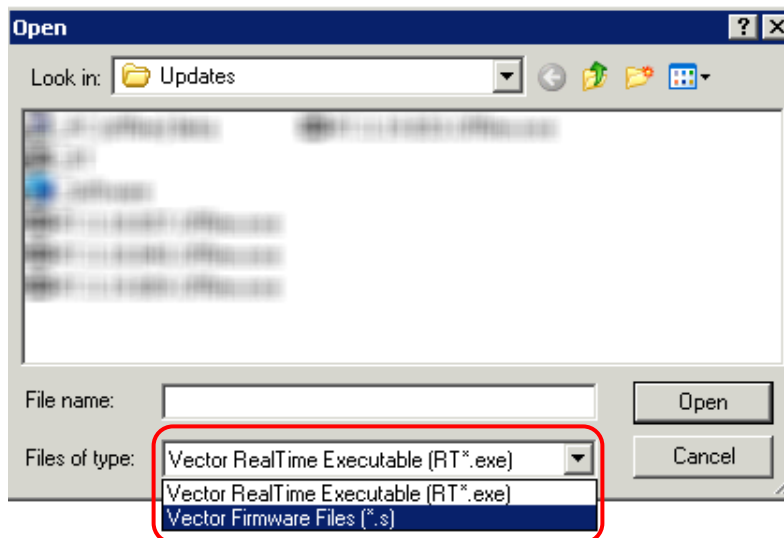
7. From the Update dialog box click on the Files of Type drop down list and select Vector Firmware Files(*.s).

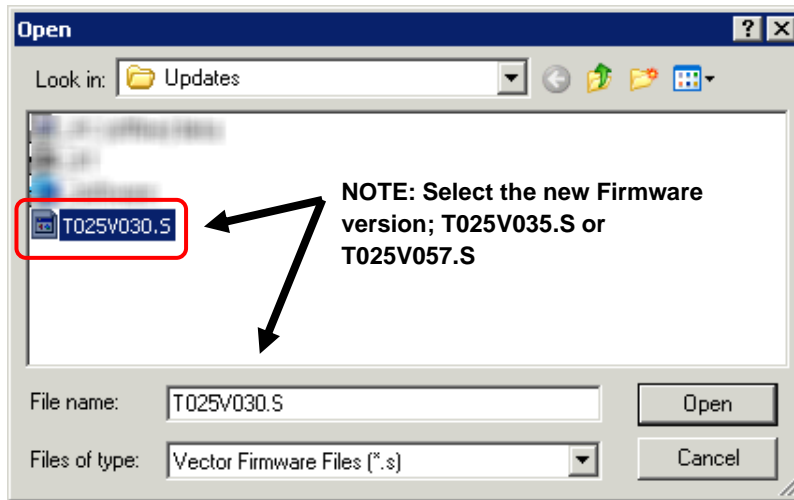
8. Select the new Firmware update file (**T025V035.S** or **T025V057.S**) and then click Open to start the Update.
